TECHNICAL INSPECTION REPORT

U.S.S. SALT LAKE CITY (CA25)

TEST ABLE

OPERATION CROSSROADS

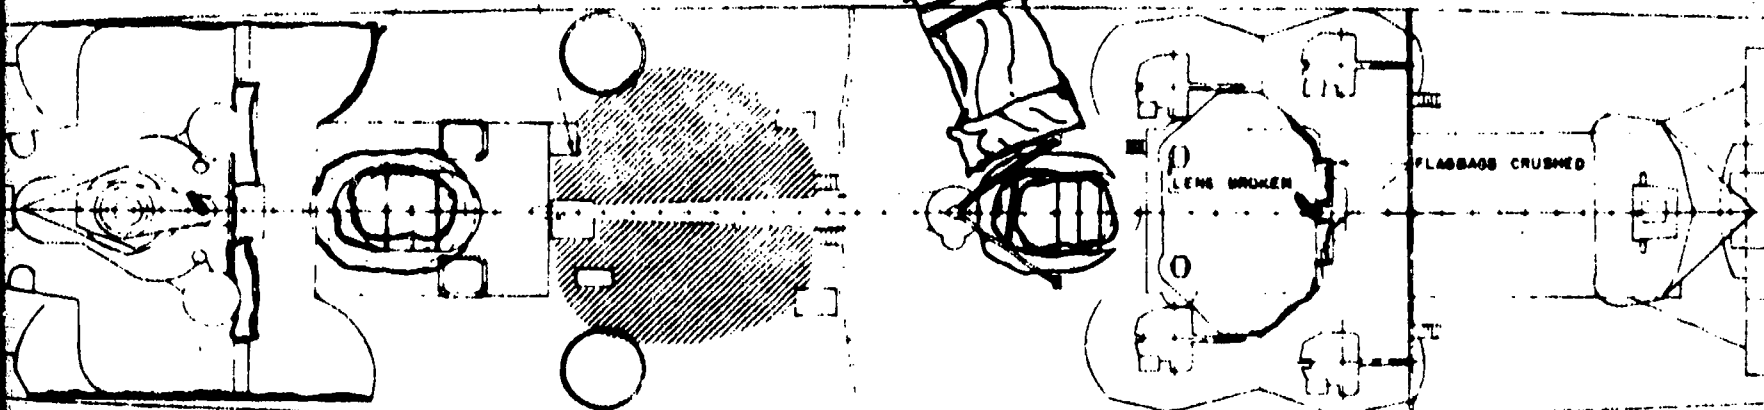
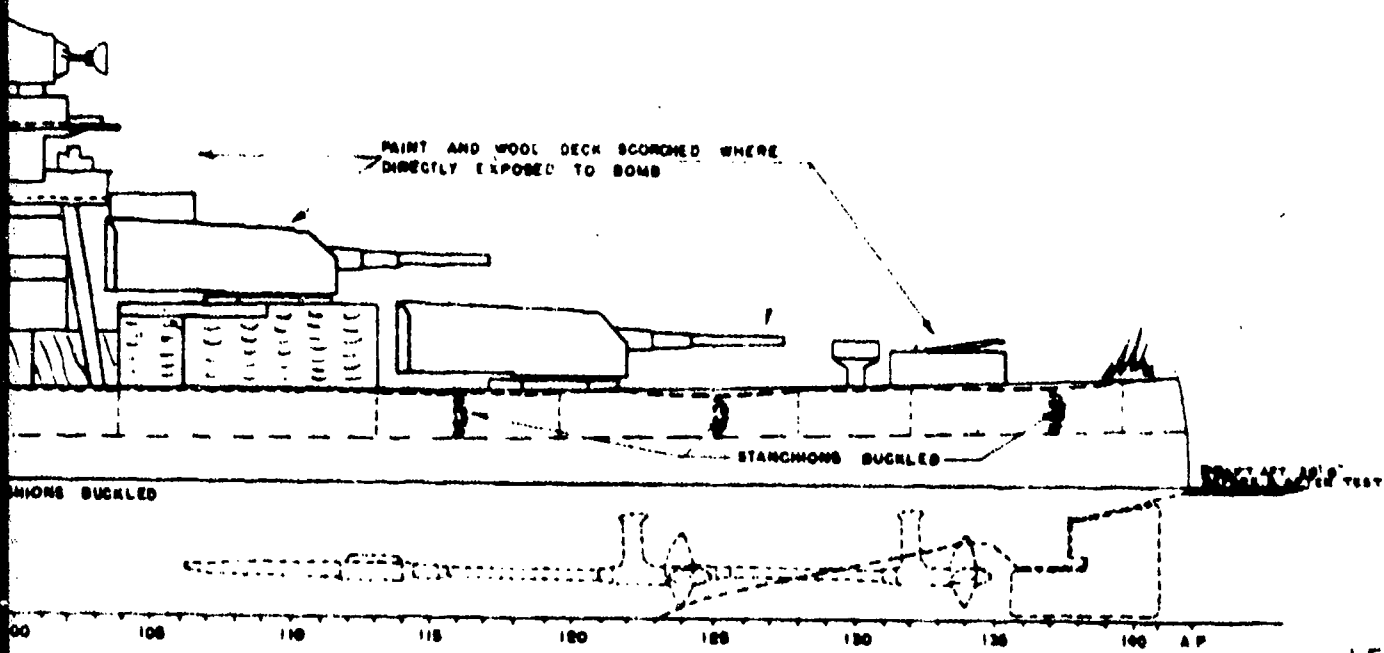
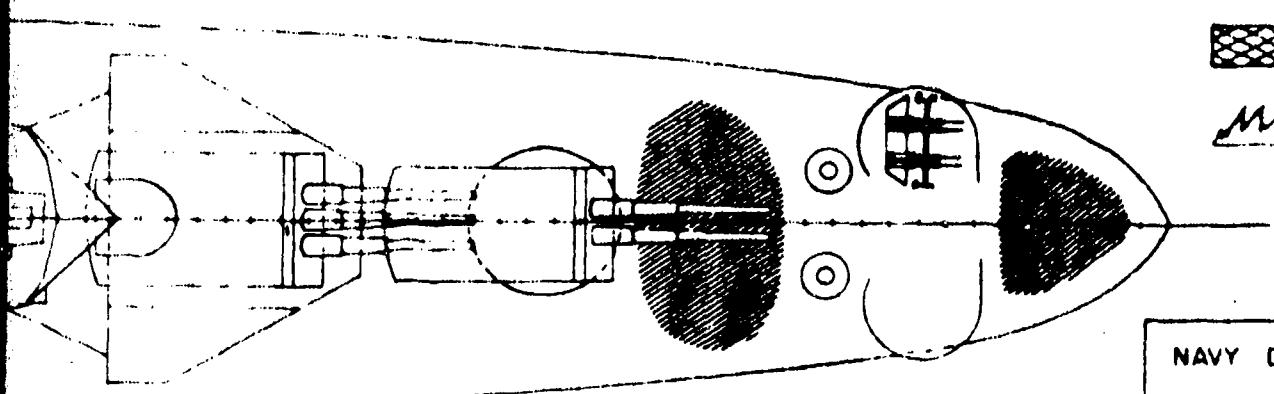
SHIP DAMAGE DIAGRAM

BOTH SEARCHLIGHTS BROKEN AT
THE BASE RING
STBD LIGHT THROWN ONTO NAV BRIDGE

MAILED
BADLY DAMAGED

VENTILATION DUCTS BADLY
DAMAGED BY DESCENDING DECK

DECK TORN AT EXHAUST VENT

STACK TORN AWAY ABOVE DECK
